TOWN OF CHAPEL HILL ADA TRANSITION PLAN

DECEMBER 2017

ADA Transition Plan

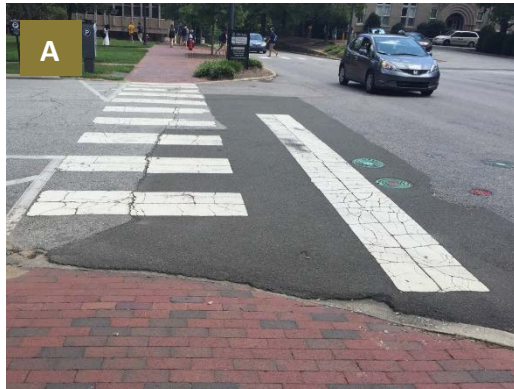
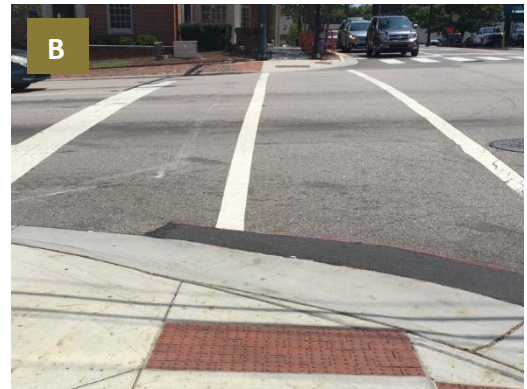
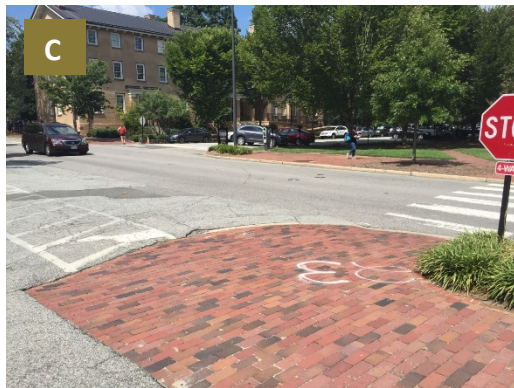
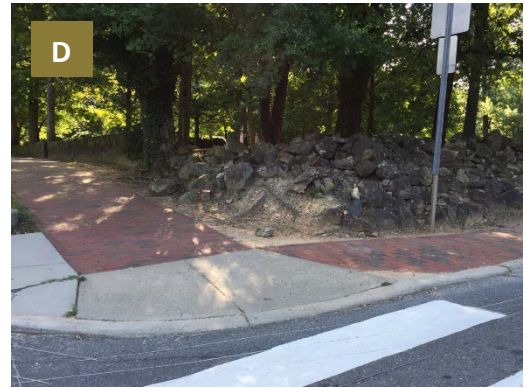
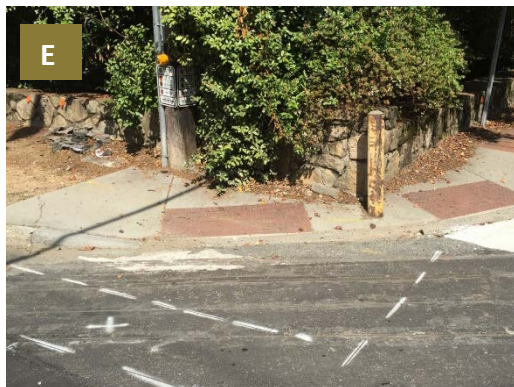
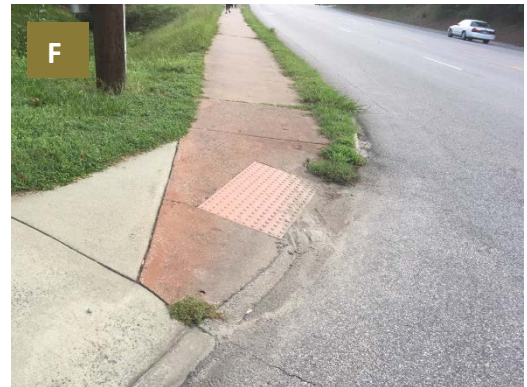
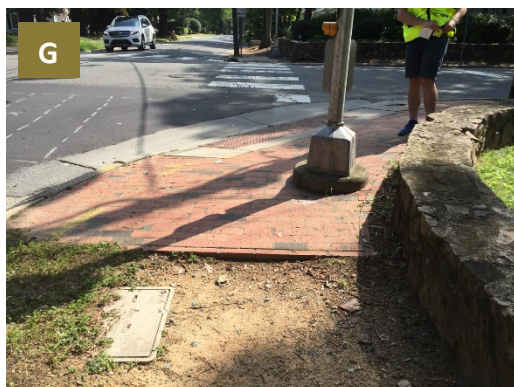
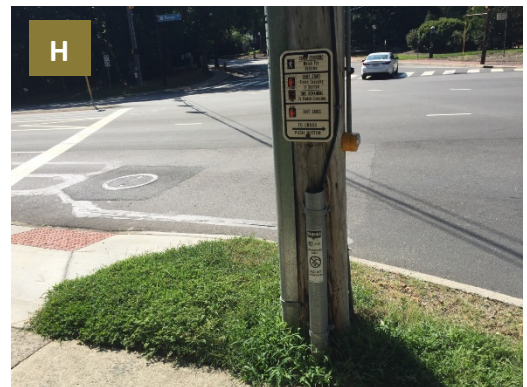
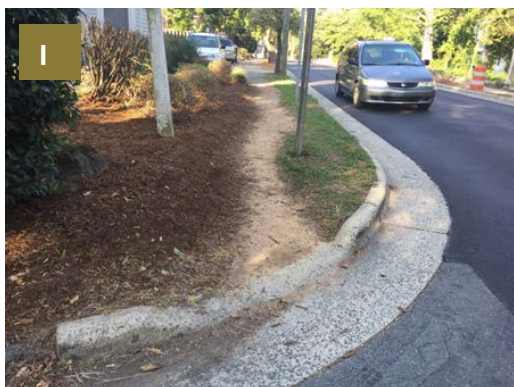
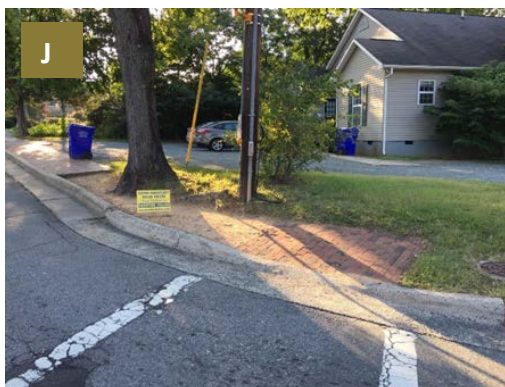
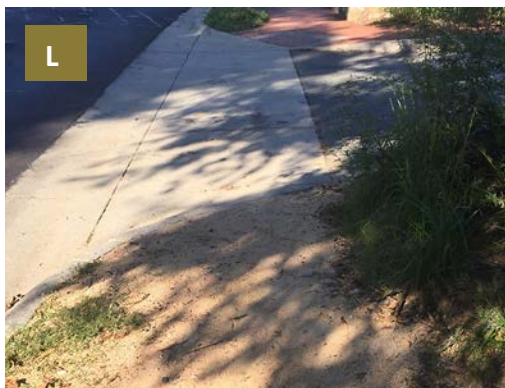
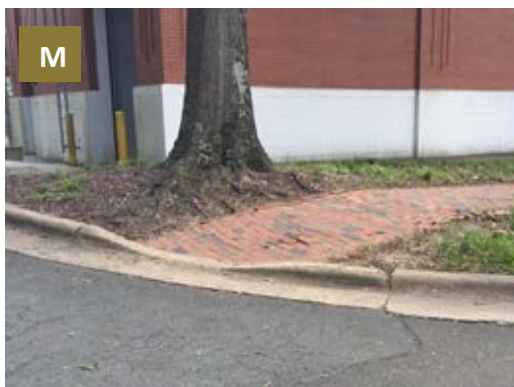
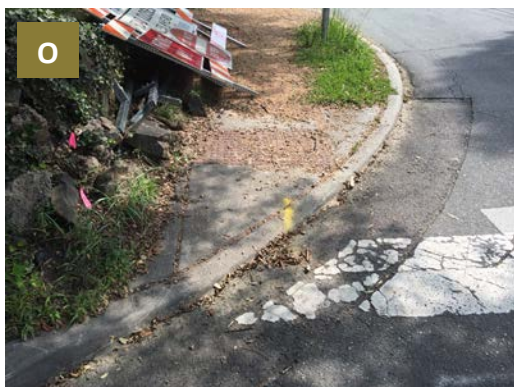
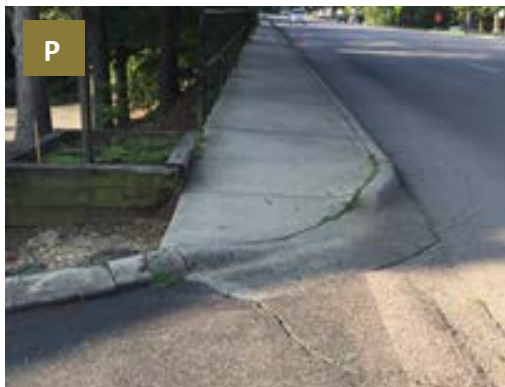
Examples of Barriers to Accessibility in Chapel Hill

- A** Misaligned stop bar, lack of accessible route at driveway
- B** Crosswalk misaligned with curb ramp
- C** Lacks curb ramps at midblock and driveway crossing
- D** Lacks level landing, exceeds running slope
- E** Obstruction to access push button
- F** Lacks level landing, domes orient into arterial street
- G** Post obstructs accessible route, sidewalk gap
- H** Push button placed on wrong side of pole, arterial street lacks crosswalk

- I Sidewalk gap
- J Sidewalk gap, lacks ramp and level landing
- K Tripping hazard greater than 1/2"
- L Excess cross slope and sidewalk gap at driveway
- M Uneven Surface, Excess slope
- N Lack of accessible route from driveway to intersection
- O Debris on ramp, lacks level landing, sidewalk gap & obstruction
- P Lacks level landing & detectible warnings, excess cross slope at driveway, lacks sufficient waiting space at transit stop

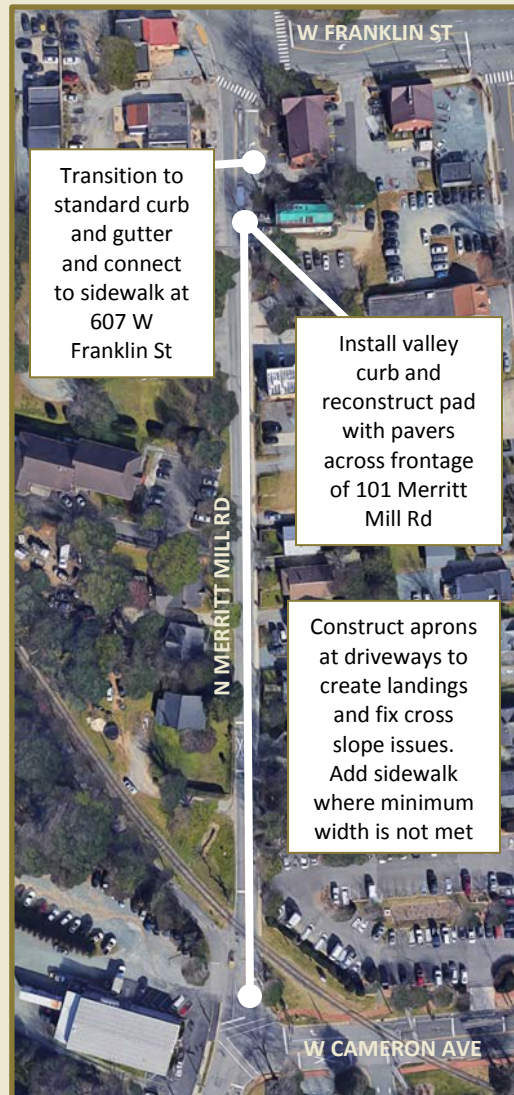
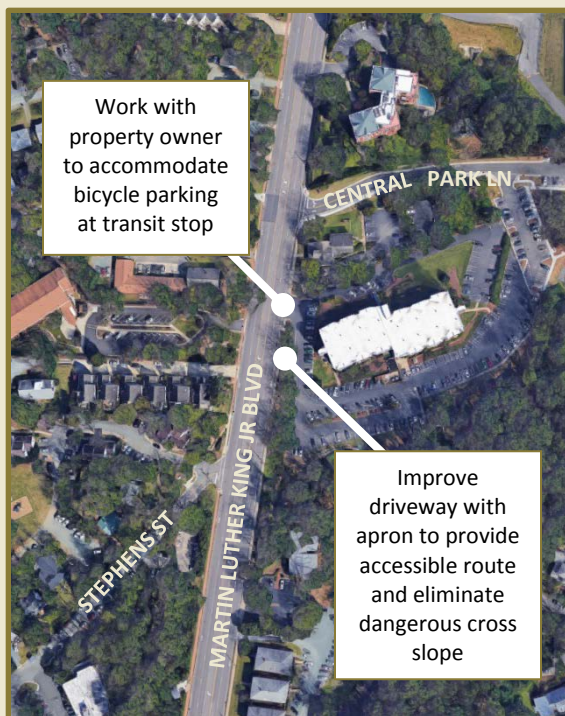
S Merritt Mill Rd between W Franklin St and W Cameron AveKey Considerations:

- No accessible route for 0.18 miles.
- Cross slopes at driveways create hazards.
- Sidewalk is narrow at back of curb without 5'x'5' landings spaced 200' apart.
- On Merritt Mill Rd near the corner of W Franklin St (101 S Merritt Mill Rd), sidewalk ends into a right turn lane/fence
